Technical Report HL-96-18
September 1996

Channel Stability Study, Flamingo Wash, Las Vegas, Nevada

by Ronald R. Copeland, Lisa C. Hubbard

Final report

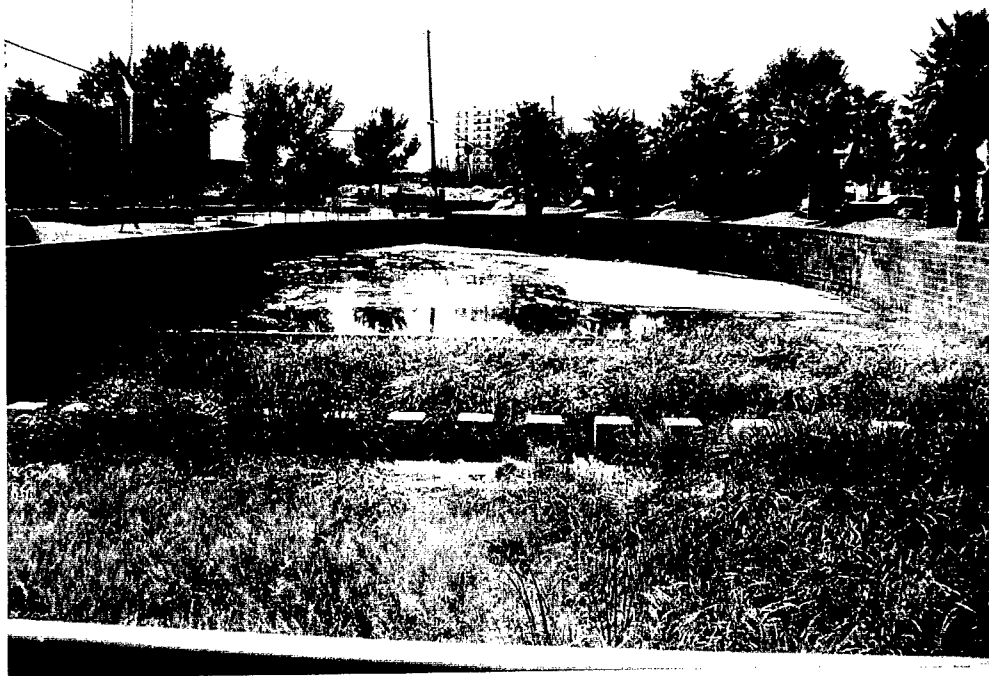
Downstream from Harmon Avenue, for about 150 ft, the channel was concrete-lined. At the end of the concrete-lined channel there was a 3- to 4-ft drop structure and an energy dissipator (Figure 2). Downstream from the dissipator the channel was grass-lined. Low vegetative ground cover was maintained on the side slopes between a driveway bridge, located about 250 ft downstream from Harmon Avenue, and a point 900 ft downstream from Harmon Avenue (Figure 3). Downstream from that point, both the invert and side slopes were grass-lined. Most of the grass in the channel was well maintained in August 1994, but there were a few spots where it had died and bare ground was exposed. Underneath the driveway bridge there were large cobbles and boulders that looked like they had been positioned to hold the low-flow channel. A paved dip road crossing was located about 600 ft downstream from Harmon Avenue. The grass-lined channel runs into a concrete multi-bay culvert which is located 1400 ft downstream from Harmon Avenue. The features described for reach 2 are shown in Plate 4.

Figure 2. Tropicana Wash - Reach 2, looking upstream at concrete-lined exit from Harmon Avenue culvert from driveway bridge, August 1994

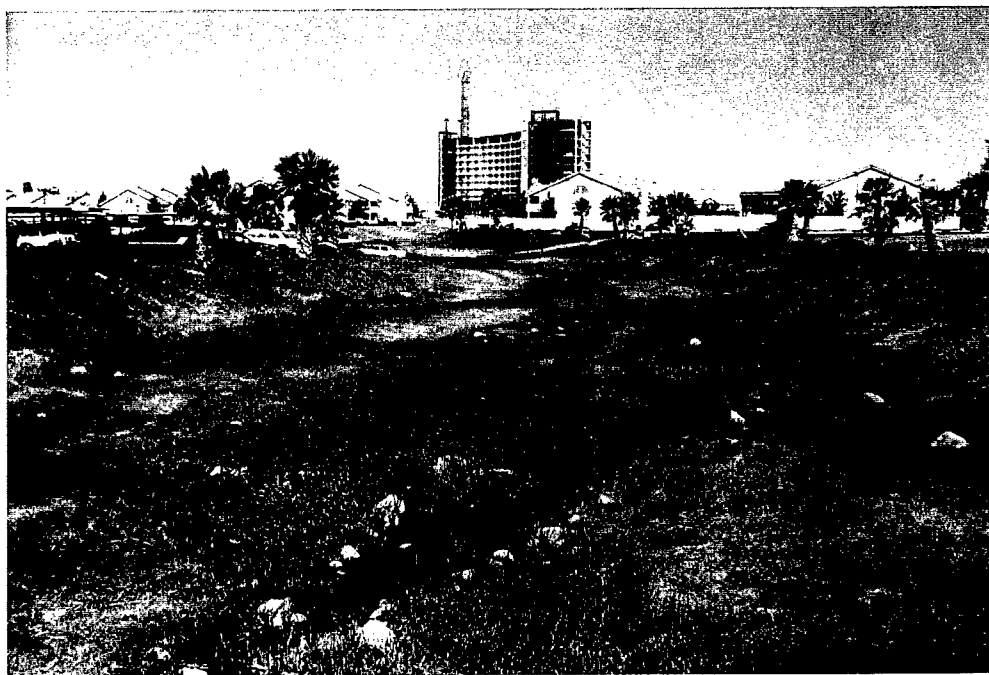
Figure 3. Tropicana Wash - Reach 2, looking downstream from driveway bridge which is 250-ft downstream from Harmon Avenue, August 1994

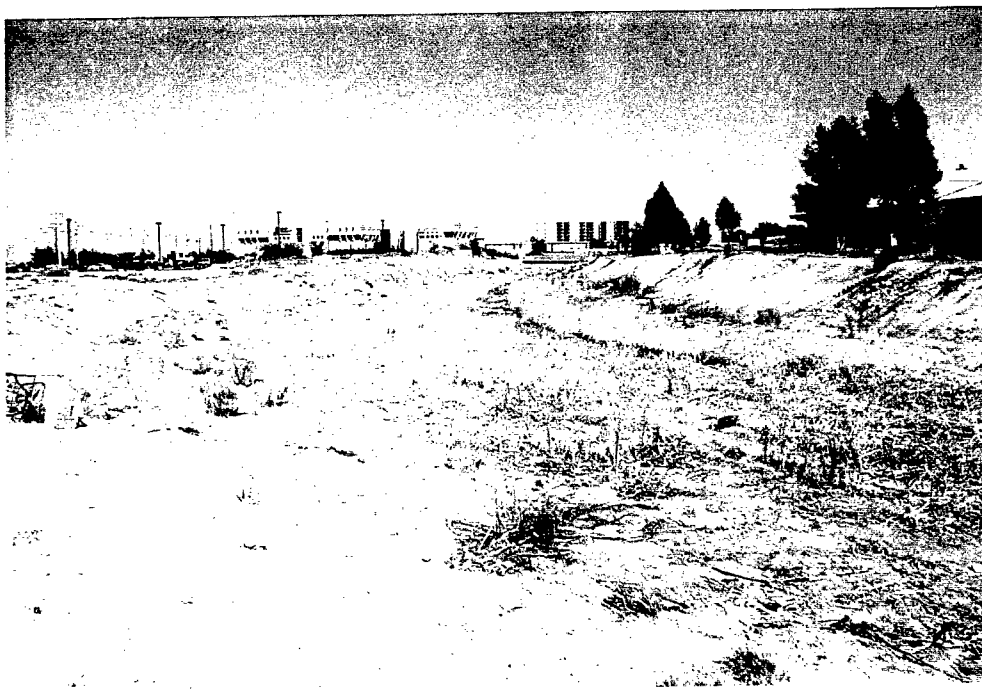
Figure 4. Tropicana Wash - Reach 4, looking downstream from culvert outlet toward Swenson Street, August 1994

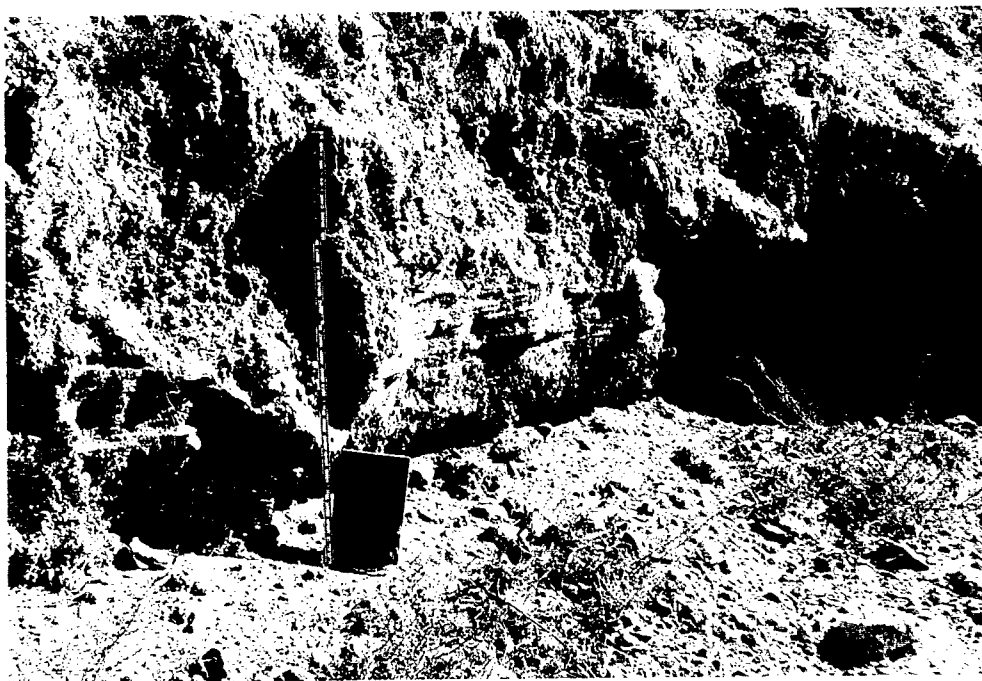
Layered deposits were observed in a three-ft-high vertical cut just upstream from Flamingo Road. As shown in Figures 5 and 6, the lower layer, which was composed of sand and pebbles, was being undercut and had a small detritus deposit at the toe. The sand and pebble layer was covered by a series of layers composed of finer material, another sand and pebble layer, and then additional layers of finer material. This suggests that bank erosion potential along the channel may vary considerably depending on the characteristics of the alluvial deposits that make up the bank at specific locations. These characteristics are typically hidden by channel grading projects and are visible only when erosion exposes the actual bank composition. Considering that the banks in this reach were observed to have layers composed of non-cohesive sand and pebbles, bank erosion potential should be considered high. Materials composing these layers are more easily removed by flowing water and are more subject to blowout by positive pore pressure in the bank than cohesive materials.

Figure 5. Tropicana Wash - Reach 5, vertical cut in right bank just upstream from Flamingo Road, August 1994

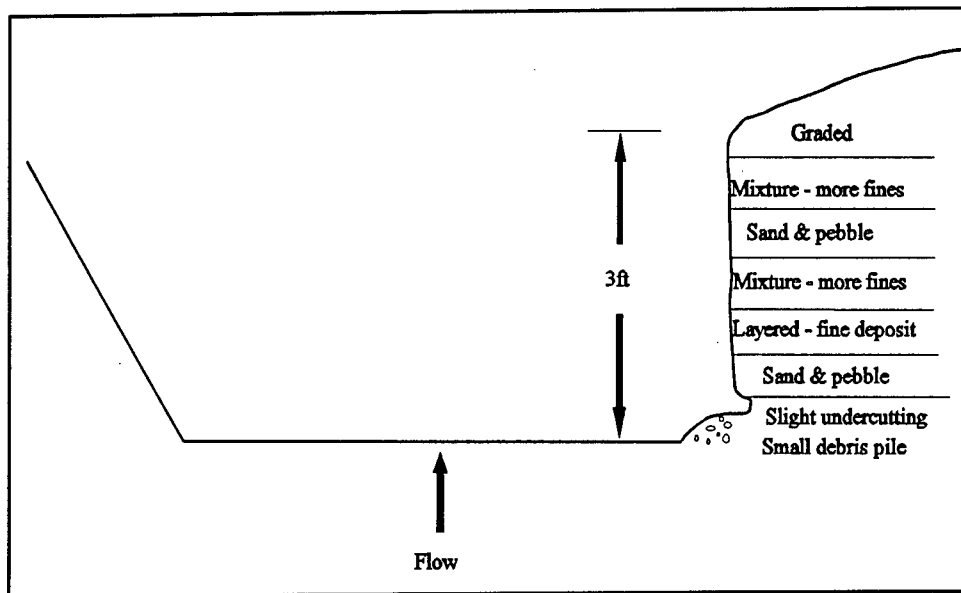
Figure 6. Tropicana Wash - Reach 5, layer description of vertical cut in right bank just upstream from Flamingo Road

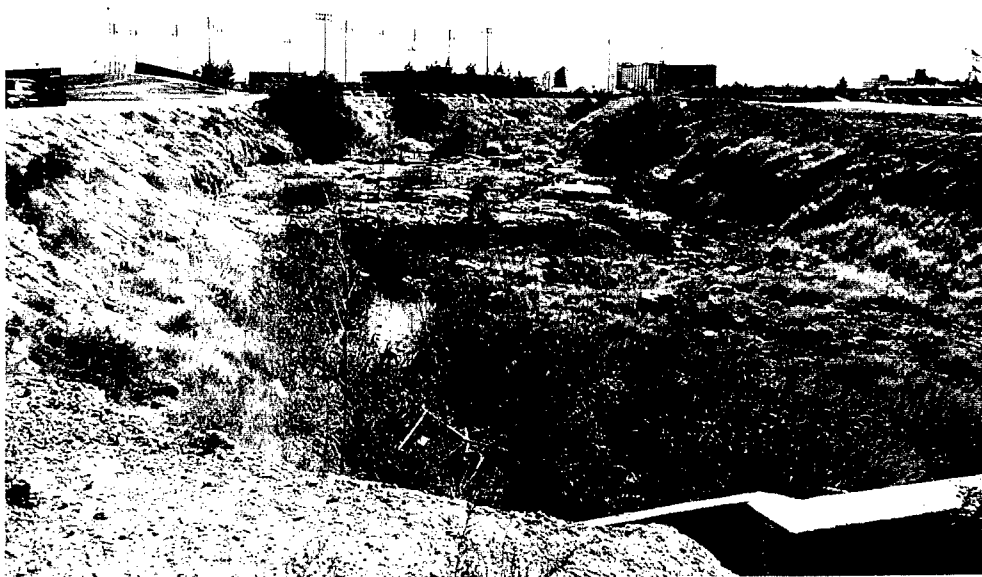
There was a major caliche drop located about 50 ft upstream from Flamingo Road. The total vertical drop was about four feet (Figure 7). The caliche drop demonstrated both the potential for degradation in this reach and the ability of the caliche deposits to form a bed control. Broken caliche fragments were observed downstream from the drop which demonstrated that the deposit was subject to failure and could not be considered a permanent hydraulic control structure. Upstream from this large drop, the caliche outcrops were not visible across the full channel width.

Figure 7. Tropicana Wash - Reach 5, looking upstream from Flamingo Road at caliche bed control, August 1994

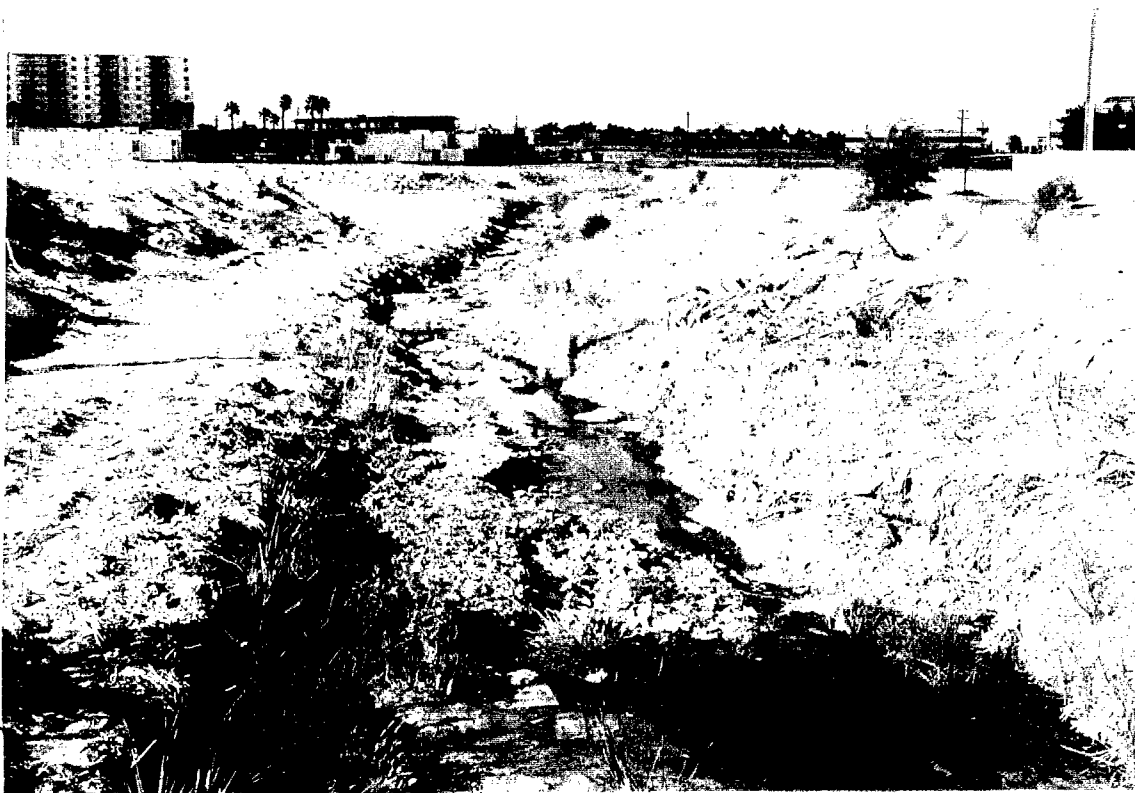
Figure 8. Tropicana Wash - Reach 6, looking downstream from Flamingo Road, April 1995

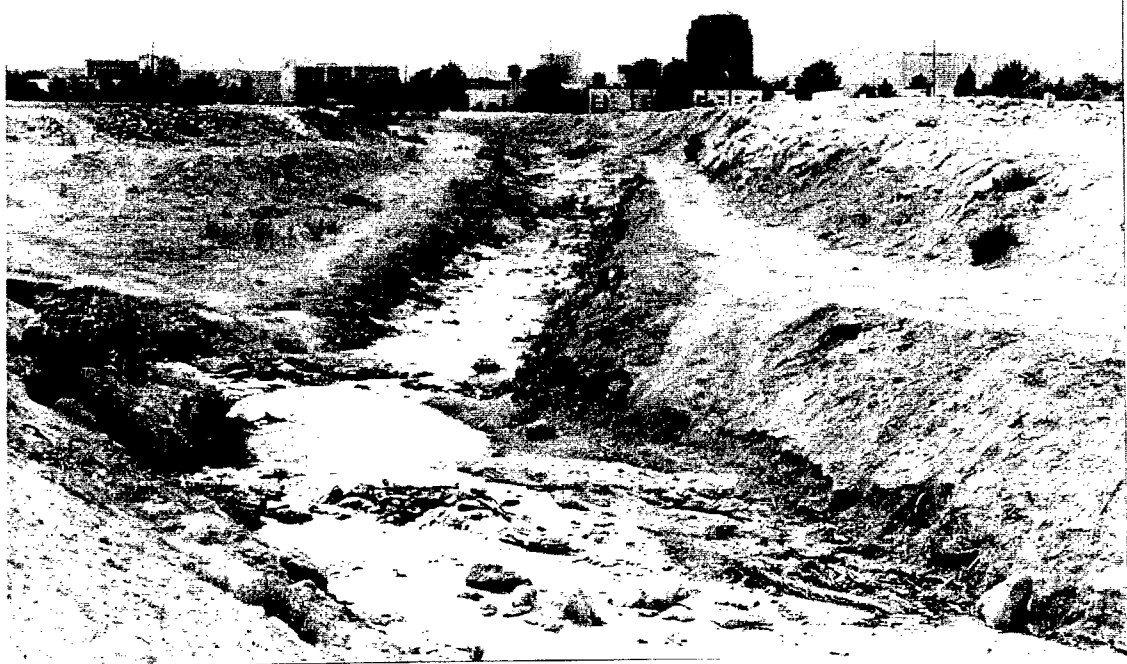
Figure 9. Flamingo Wash - Reach 6, looking upstream from the Tropicana Wash confluence, April 1995

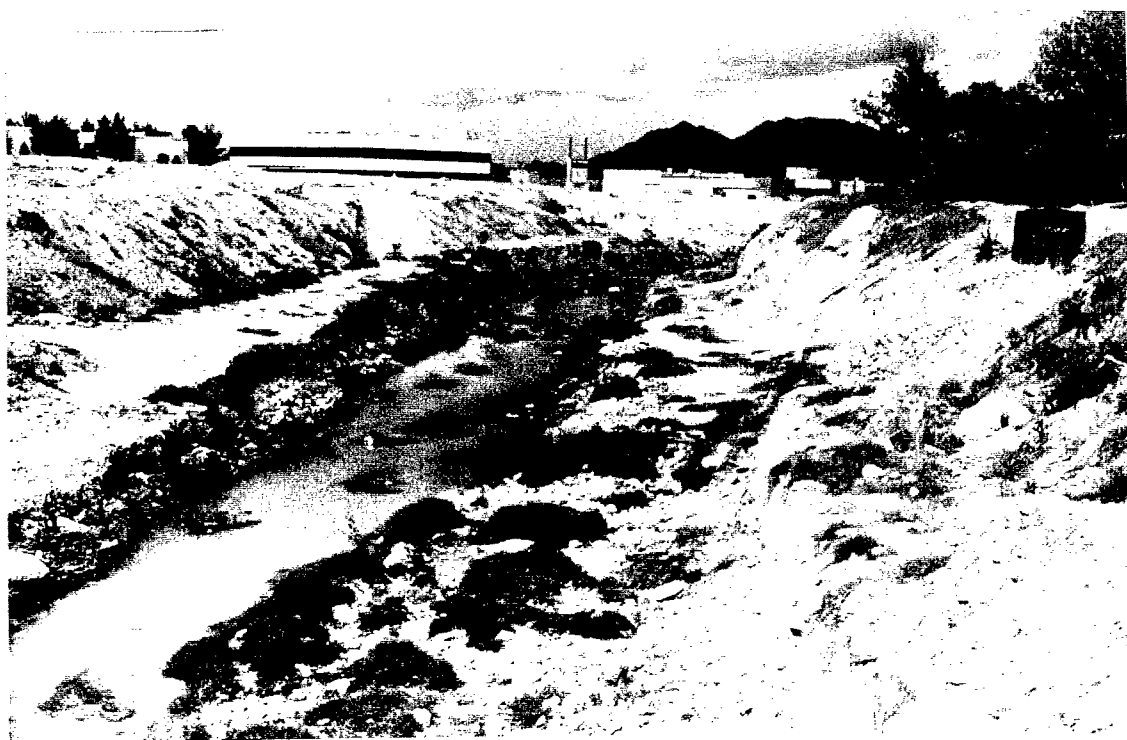
Downstream from Cambridge Street the graded channel generally had a trapezoidal shape with a 10-ft-wide low-flow channel cut to a depth of 4 to 5 ft (Figure 10). The nearly vertical upper banks consisted of sand and gravel. The bank material was quite hard even though the presence of significant cohesive material was not apparent. The upper layers of these banks were composed of loose material. Concrete-lined bank protection extended about 100 ft upstream from Maryland Parkway on the right bank, and about 300 ft upstream on the left bank. The concrete-lined side slopes were not keyed into the bed. Generally, the bottom elevation of the slab was at the existing channel bed elevation. However, erosion had occurred at the base of the lined side slopes at several locations (Figure 11). Further erosion could undercut the slabs and cause failure along a significant reach of the channel. Geometric irregularity associated with slab failure would accelerate the local erosion process. A plan view of reach 7 is shown in Plate 7.

Figure 10. Flamingo Wash - Reach 7, looking downstream from Cambridge Street, April 1995

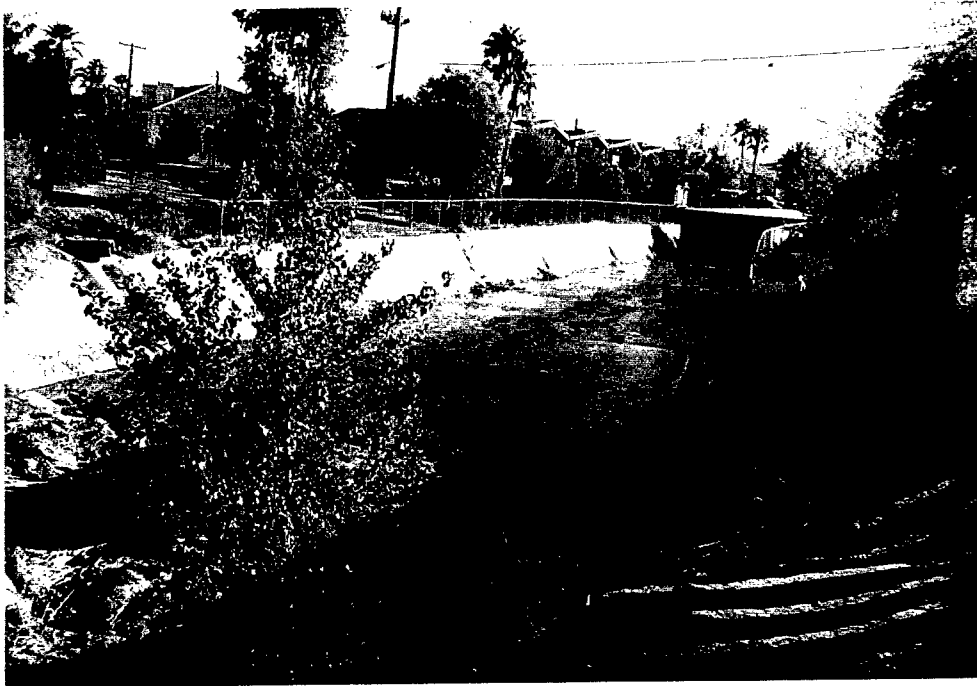
About 1400 ft downstream from Maryland Parkway, the channel was fully concrete-lined for about 800 ft (Figure 14). Tennis courts had been constructed over the channel about midway along the concrete-lined channel. On the upstream side of the tennis courts there was a 2.5-ft drop and downstream, another 2.5-ft drop. In August 1994, a 5-ft-deep scour hole was observed at the end of the concrete-lined channel (Figure 15). Foundation material from under the concrete slab had been scoured. In addition, immediately downstream from the end of the concrete-lined channel the scour was five feet below the toe of concrete-lined slide slopes on the left bank and had undercut the slab. By March 1996, angular gravel-size material had been imported to this site filling the scour hole and returning the bed elevation adjacent to the side slopes to the base elevation of the concrete-lined side slope.

Figure 14. Flamingo Wash - Reach 8, looking downstream at entrance to concrete-lined channel, August 1994

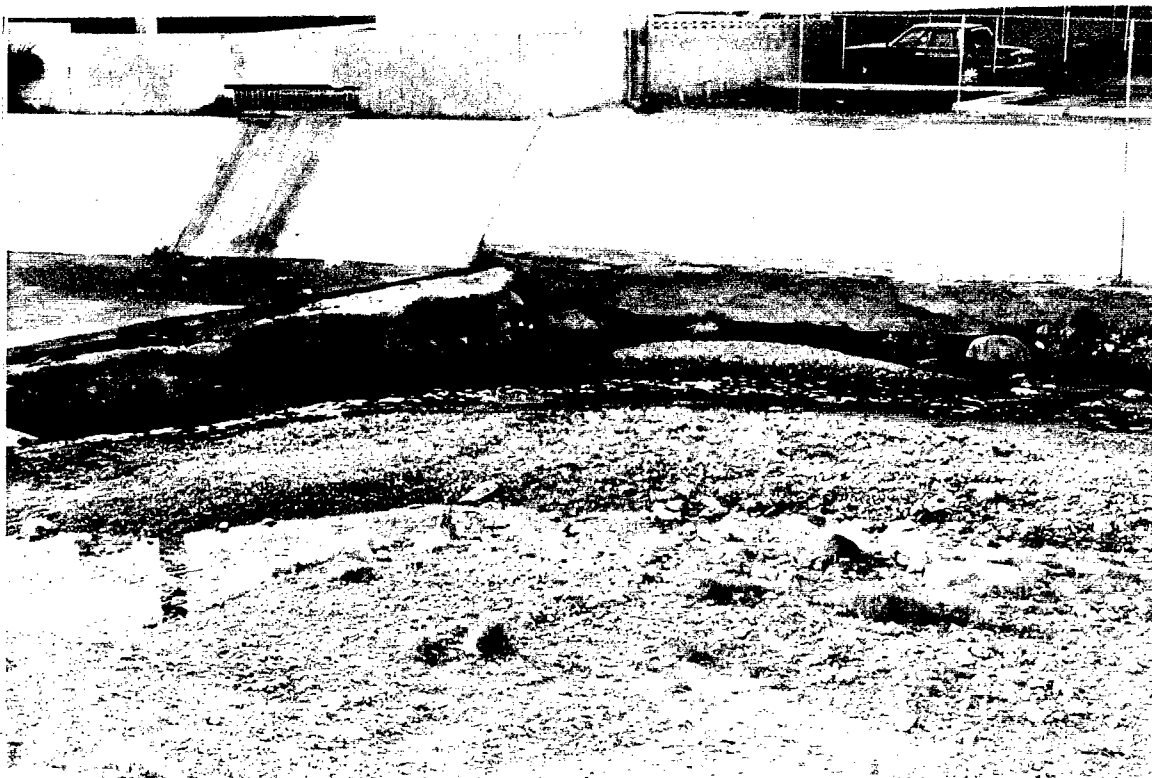
Figure 15. Flamingo Wash - Reach 8, erosion at end of concrete-lined channel, April 1995

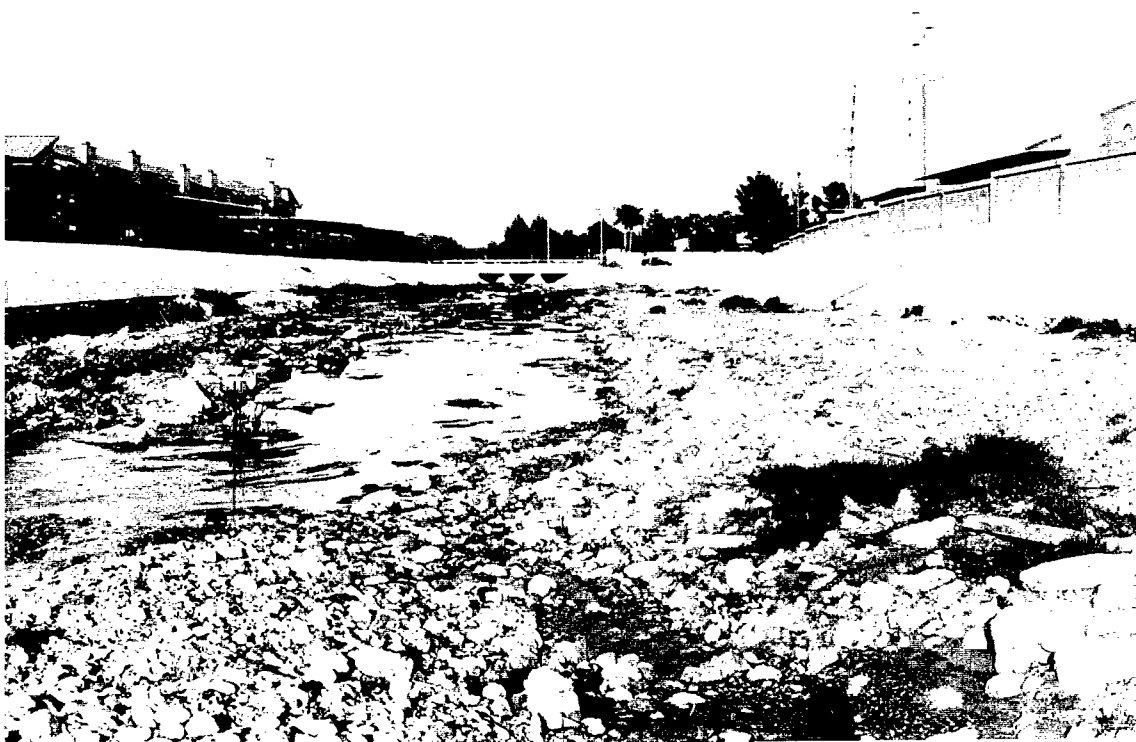
Downstream, the remaining 800-ft of reach 8 had a trapezoidal channel with concrete-lined side slopes and a natural invert (Figure 16). The natural invert had sparse grass on the bed, and a low flow channel had developed to a depth of about 1 ft in August 1994. Degradation of about 2 to 3 ft had occurred below the toe of the concrete side slopes at some locations. No evidence of concrete footings was observed. By March 1996, berms had been constructed from imported angular gravel-sized material along both banks throughout this reach. Just upstream of Spencer Street there was a concrete access road that faced upstream on the right bank. This would act as a launch for flood flows.

Figure 16. Flamingo Wash - Reach 8, looking downstream toward Spencer Street, April 1995

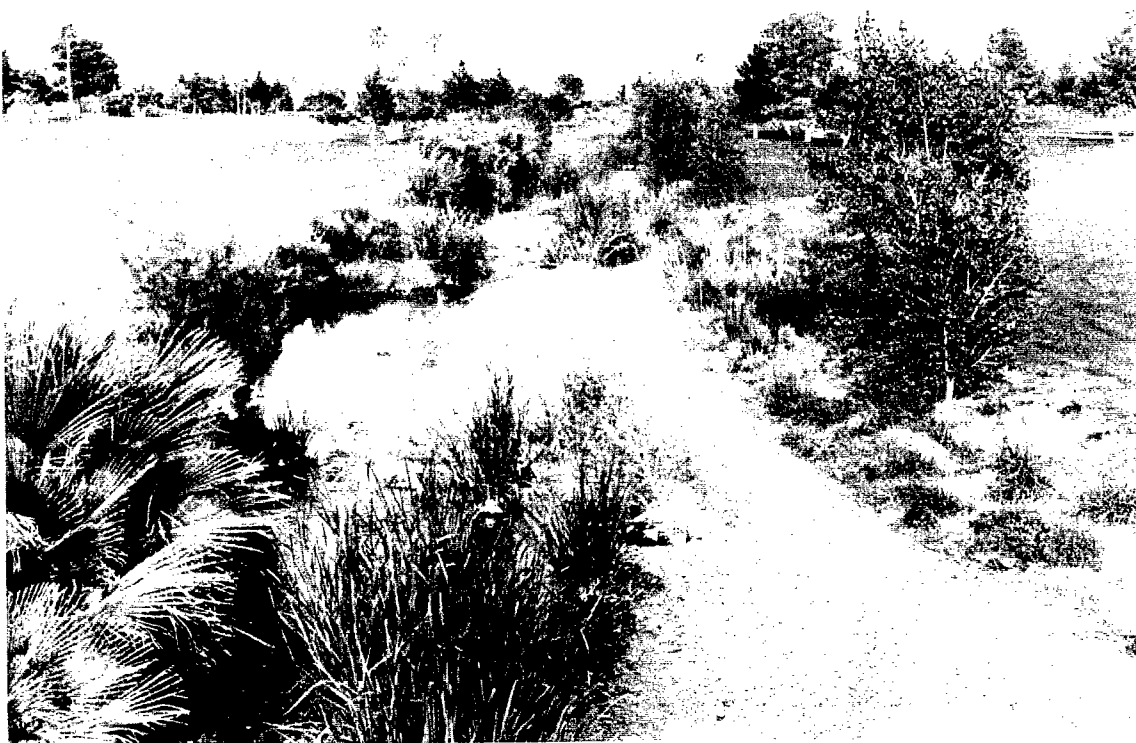
Downstream from the Spencer Street culvert was a short transitional channel leading into a more natural channel through a golf course. The first 150 ft downstream from the culvert had concrete-lined side slopes and an unprotected invert. There was a 2.5-ft-high sill at the end of the concrete-lined side slopes. Downstream from the sill the banks were composed of loose graded material. The channel bed through the golf course appeared to be unmaintained with significant vegetation. Gravel bars were observed in the bed. The mild sloping banks were covered with well maintained grass (Figure 17).

Figure 17. Flamingo Wash - Reach 9, looking downstream through golf course, near Spencer Street, April 1995

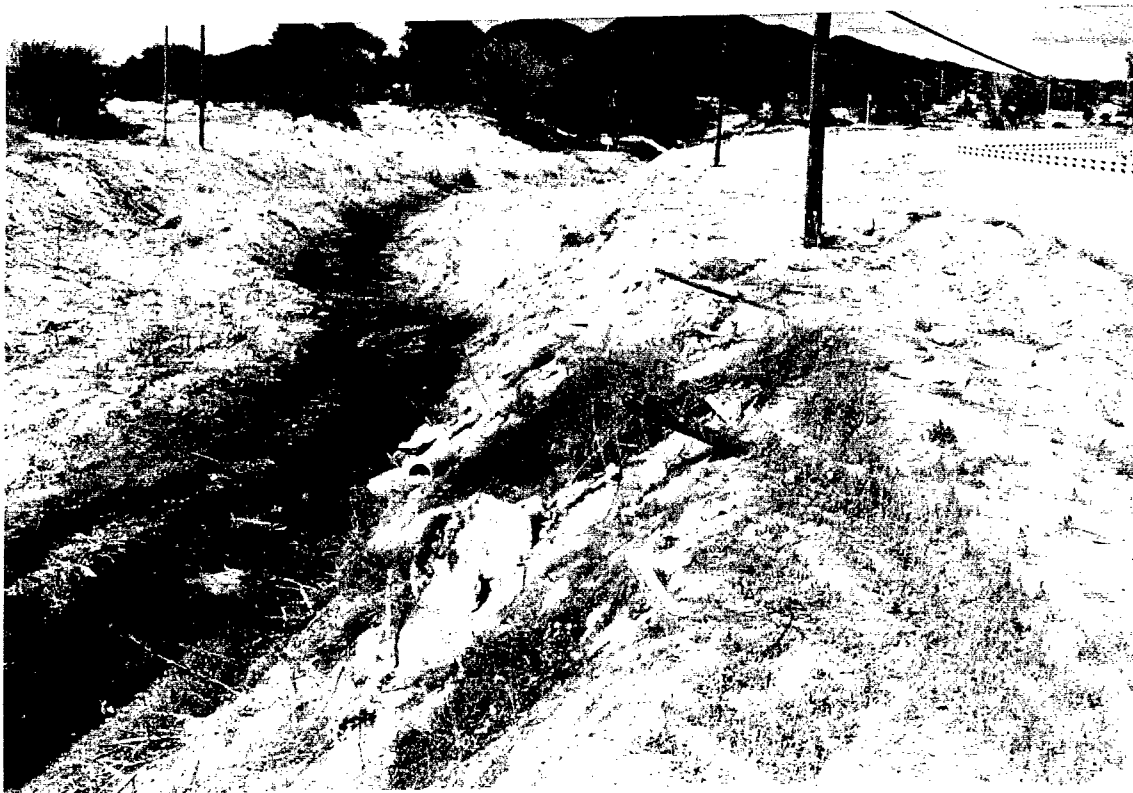
equipment. However, broken caliche fragments were present in the bed at several locations along the reach. The bank material was very loose. This reach has a very high potential for erosion and instability (Figure 19).

Figure 19. Flamingo Wash - Reach 10, looking downstream, about halfway between Eastern Avenue and McLeod Drive, April 1995

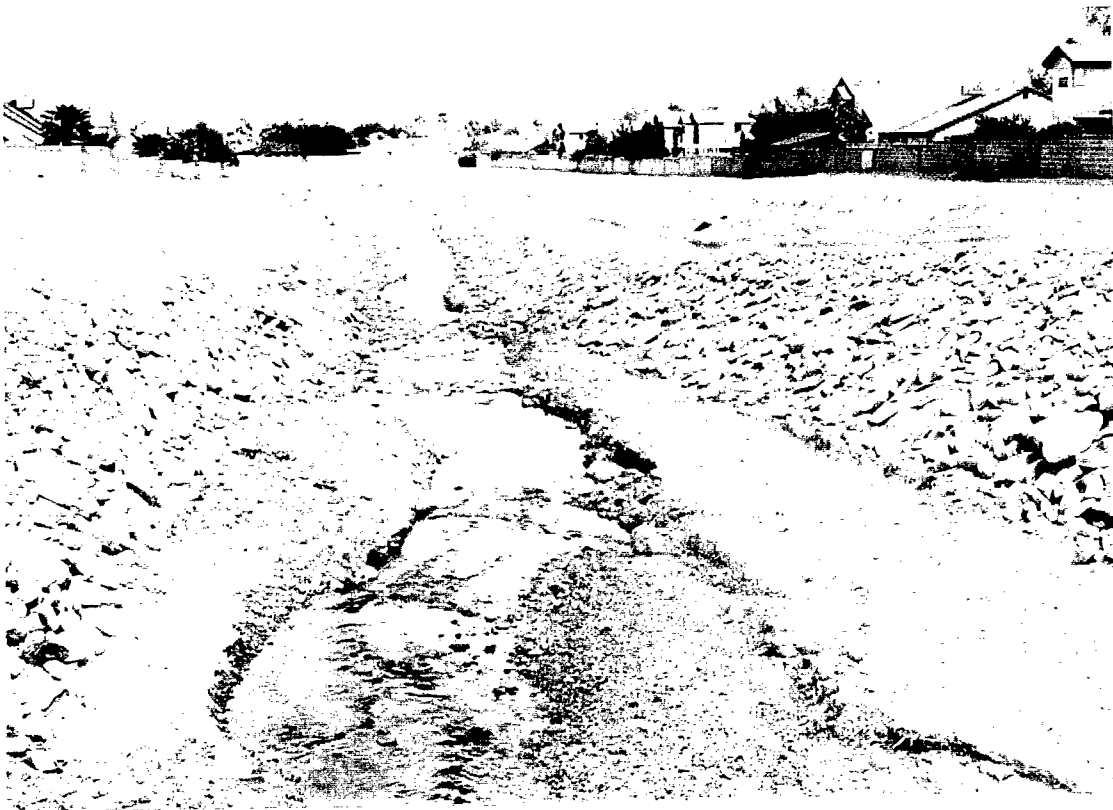
Downstream from Mojave Road was a shaped trapezoidal channel with a low-flow channel about 8 ft deep by 20 ft wide (Figure 20). Riprap had been placed on the right outer bank of the low-flow channel. A mobile armor layer was present in the bed at some locations. A caliche control with a 1.5-ft drop was located about 1300 ft downstream from Mojave Road near a local drainage inlet. A point bar had developed downstream from the caliche outcrop. Bank erosion was observed in the low-flow channel in areas without riprap protection. Between August 1994 and April 1995 the longitudinal extent of the riprap protection in the low-flow channel had been increased significantly. Bank erosion observed at several locations in August 1994 had been repaired. In unprotected reaches, there was a natural meander pattern present in the low-flow channel that had a much smaller wave length than the main channel curvature. This resulted in bank erosion on the inside of the channel bed as shown in Figure 21. The composition of the low-flow channel banks in this reach was varied. There was sand in the lower layers, and either weakly cemented sand and gravel or just loose sand and gravel in the upper layers. The bank angles observed were relatively steep, which was surprising considering the non-cohesive appearance of the bank material. The banks seemed natural but asphalt and trash were present. The banks may have been shaped using dumped material and then reworked by the stream, resulting in the layered appearance.

Figure 20. Flamingo Wash - Reach 13, looking downstream from Mojave Road, April 1995

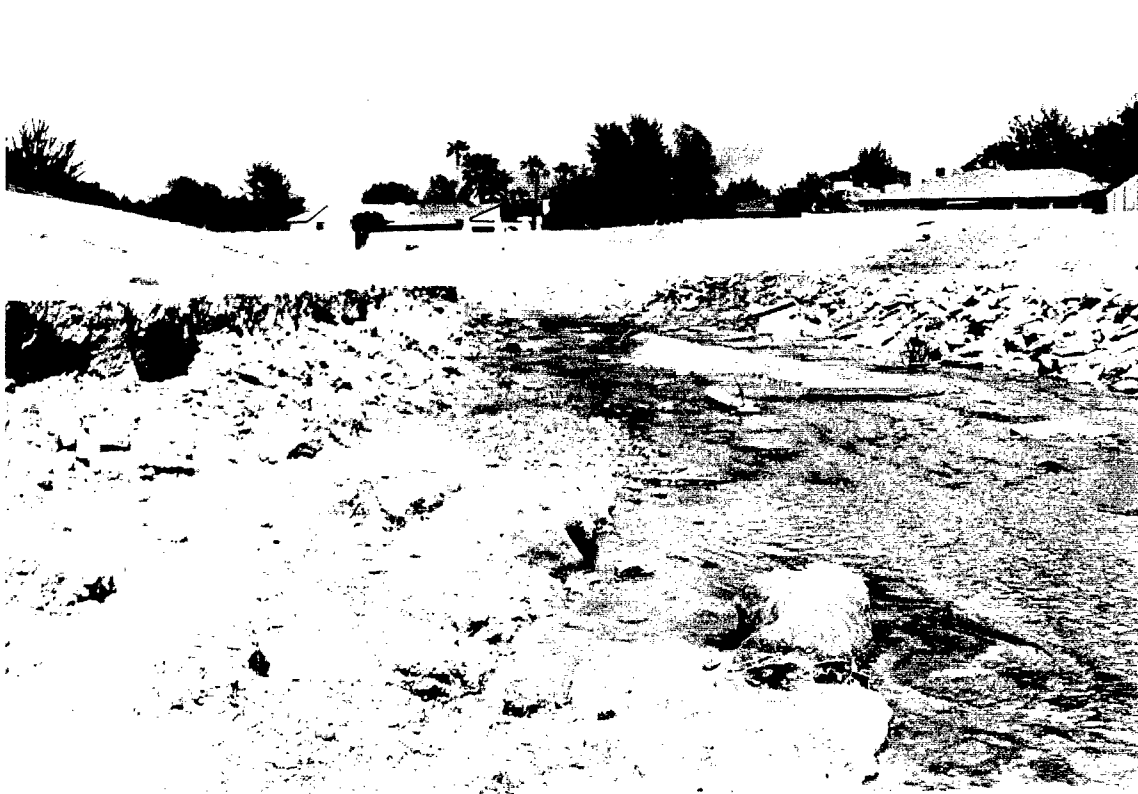
Figure 21. Flamingo Wash - Reach 13, downstream from Mojave Road looking at erosion on Inside of channel bend, April 1995

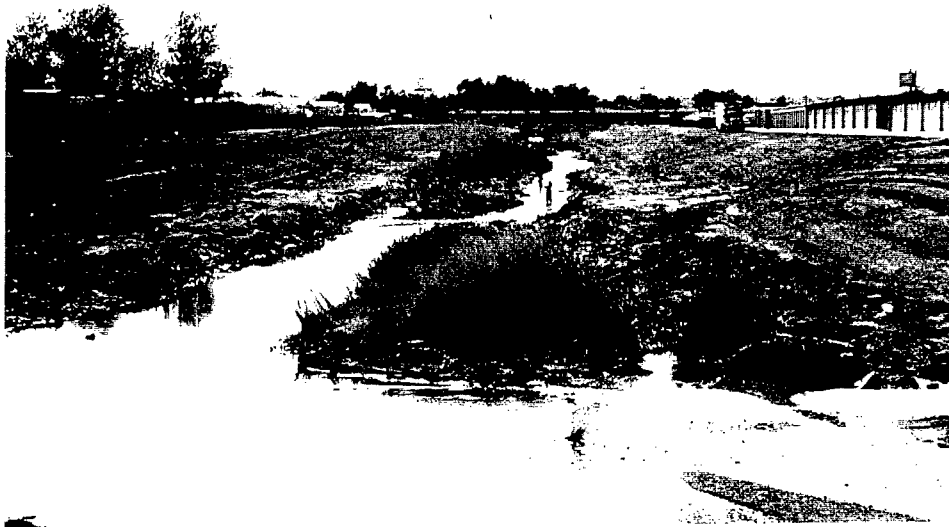
Downstream from Interstate 515 was a graded trapezoidal channel with a cut low-flow channel. The low-flow channel became more poorly defined as it approached Lamb Boulevard. The main channel in this reach was wider, and the banks were not as steep as further upstream. In August 1994 meandering was observed in the 1- to 2-ft deep and 30- to 40-ft wide low-flow channel. Gabions placed on the right bank, just downstream from Interstate 515, were in danger of failing due to backwashing. Other than this short reach of gabions there was no bank protection in the reach. In August 1994 grass that had been growing in the channel bed was yellow and appeared to have been recently sprayed with herbicide. The low-flow channel had been reshaped by April 1995, removing signs of deposition and meandering (Figures 22 and 23).

Figure 22. Flamingo Wash - Reach 16, looking upstream from Lamb Boulevard, August 1994

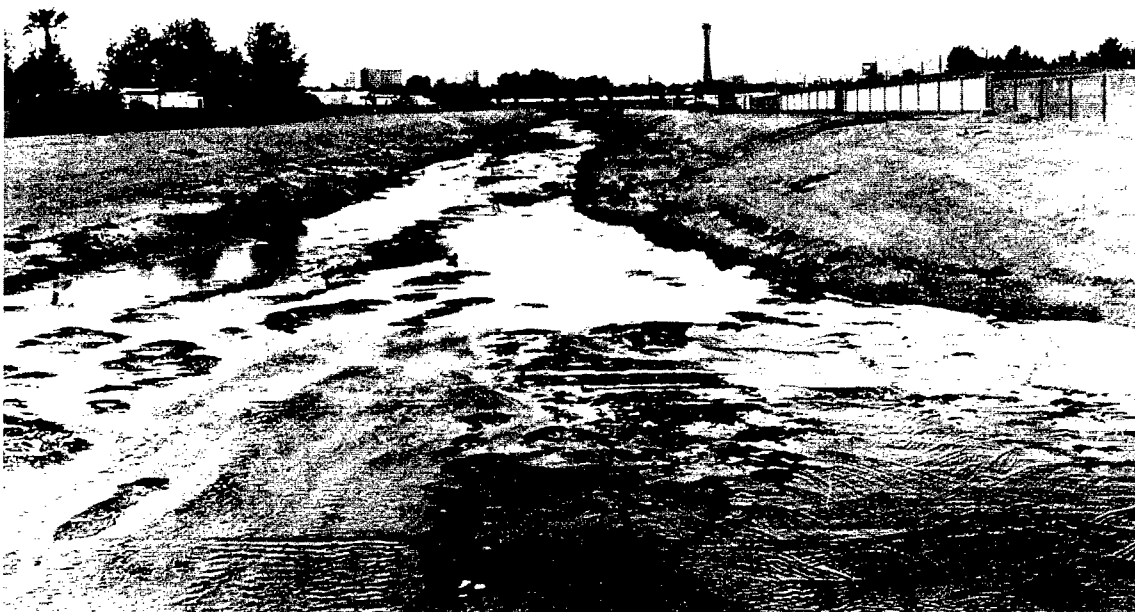
Figure 23. Flamingo Wash - Reach 16, looking upstream from Lamb Boulevard, April 1995

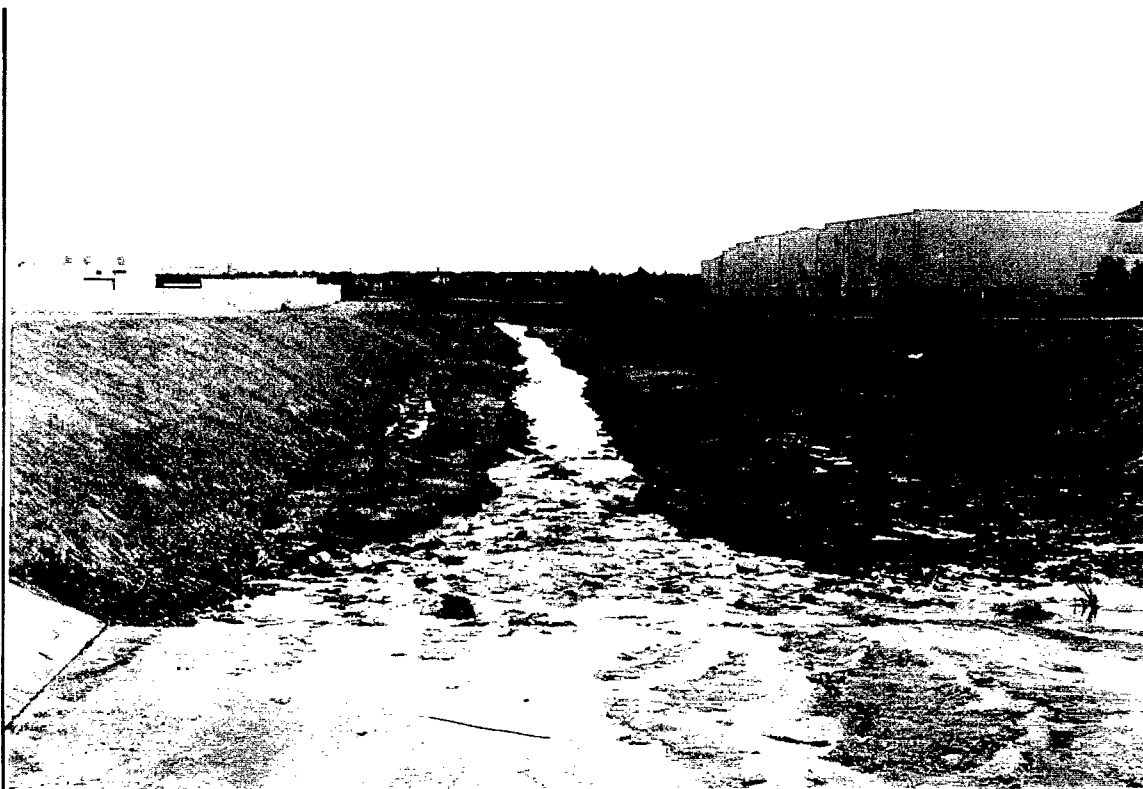
Figure 25. Flamingo Wash - Reach 17, looking downstream from Lamb Boulevard, April 1995

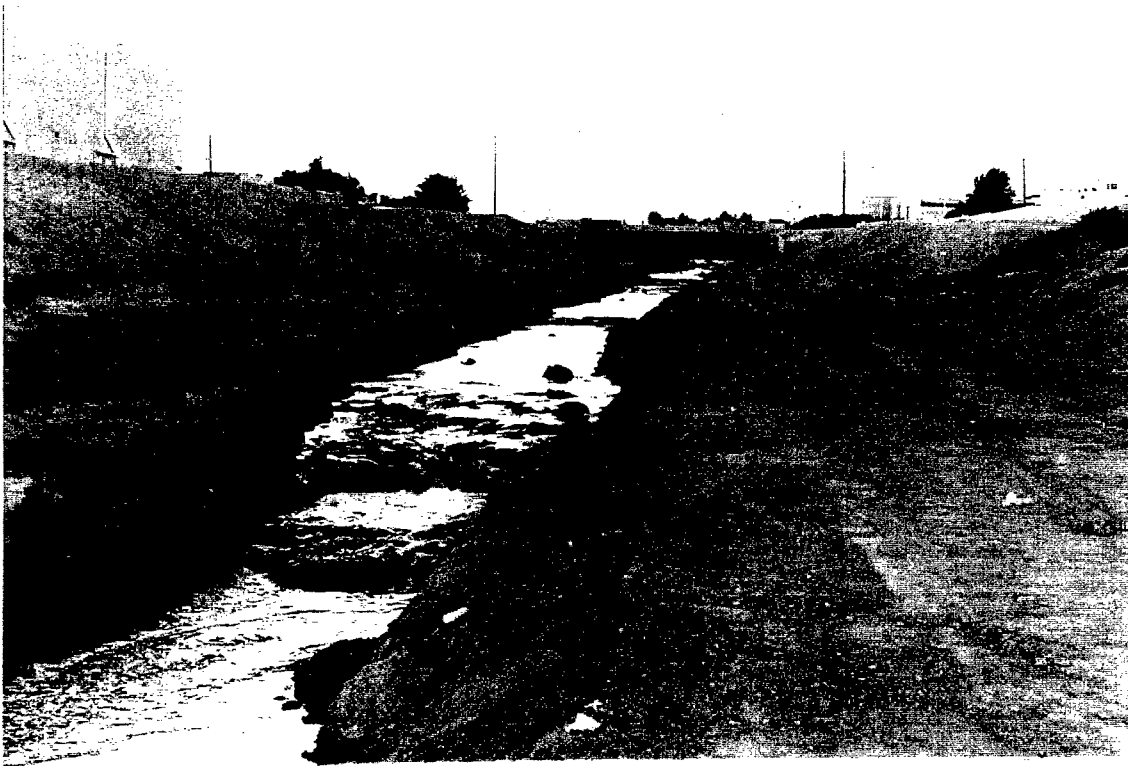
Figure 27. Flamingo Wash - Reach 17, caliche headcut, April 1995

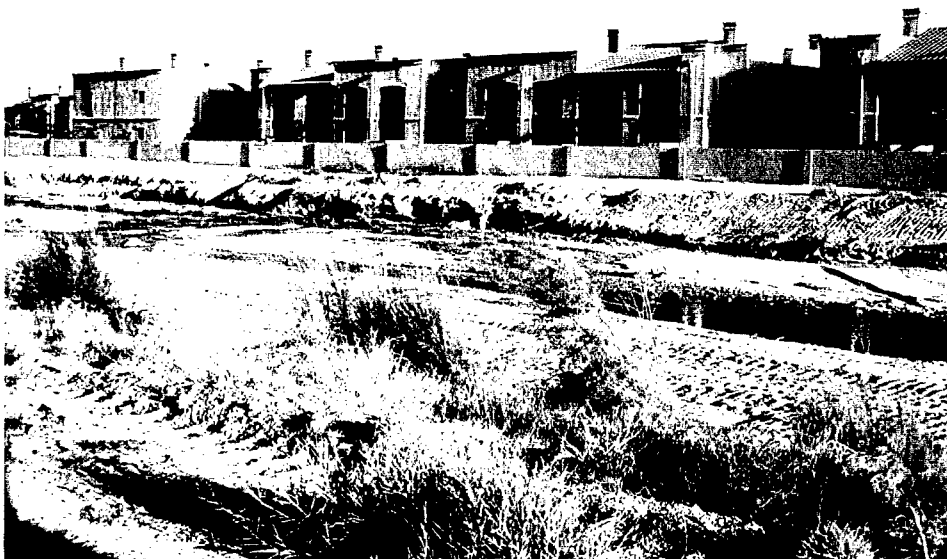
Figure 29. Flamingo Wash - Reach 17, erosion on right bank, upstream from Nellis Boulevard, August 1994
